# Debris/Ice/TPS Assessment And Photographic Analysis For Shuttle Mission STS-44

Gregory N. Katnik  
NASA/Kennedy Space Center

November 24, 1991

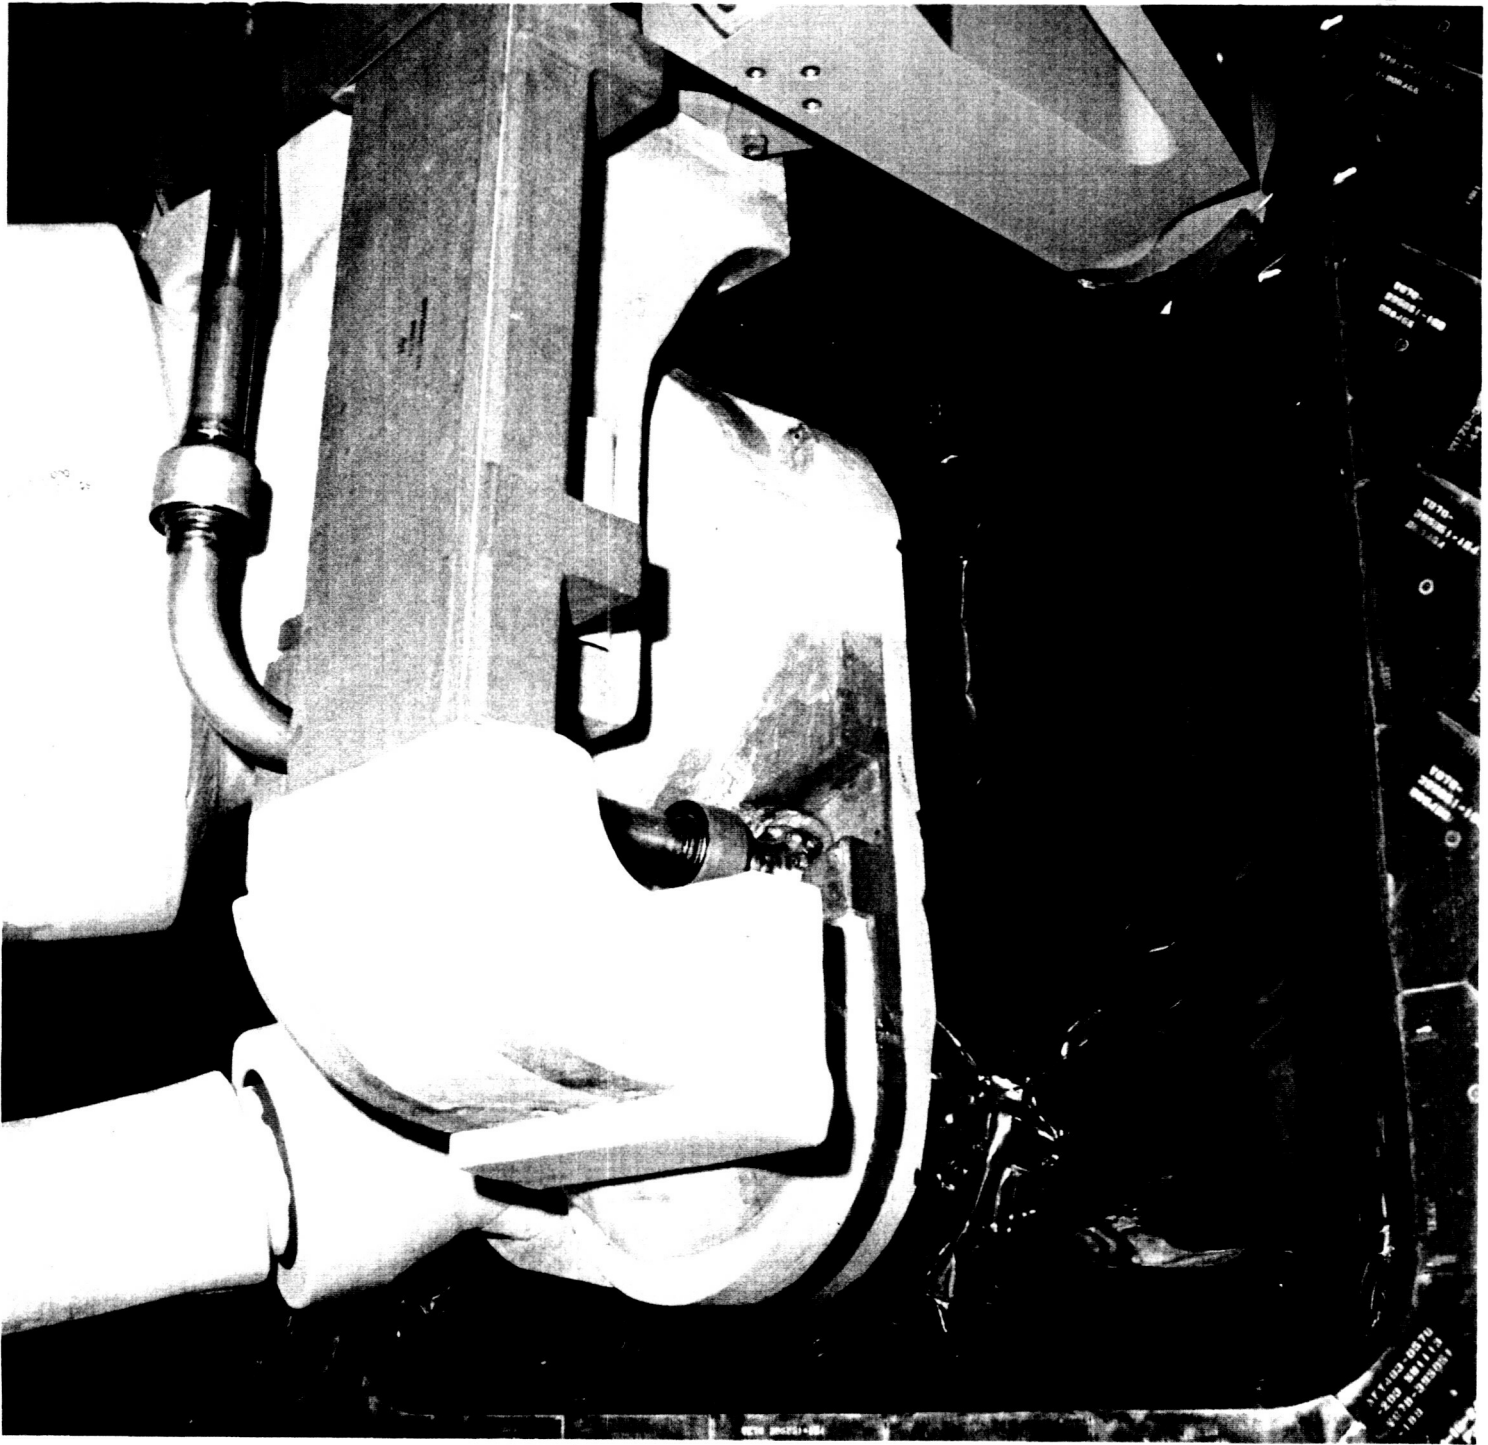
Overall view of the LH2 ET/ORB umbilical

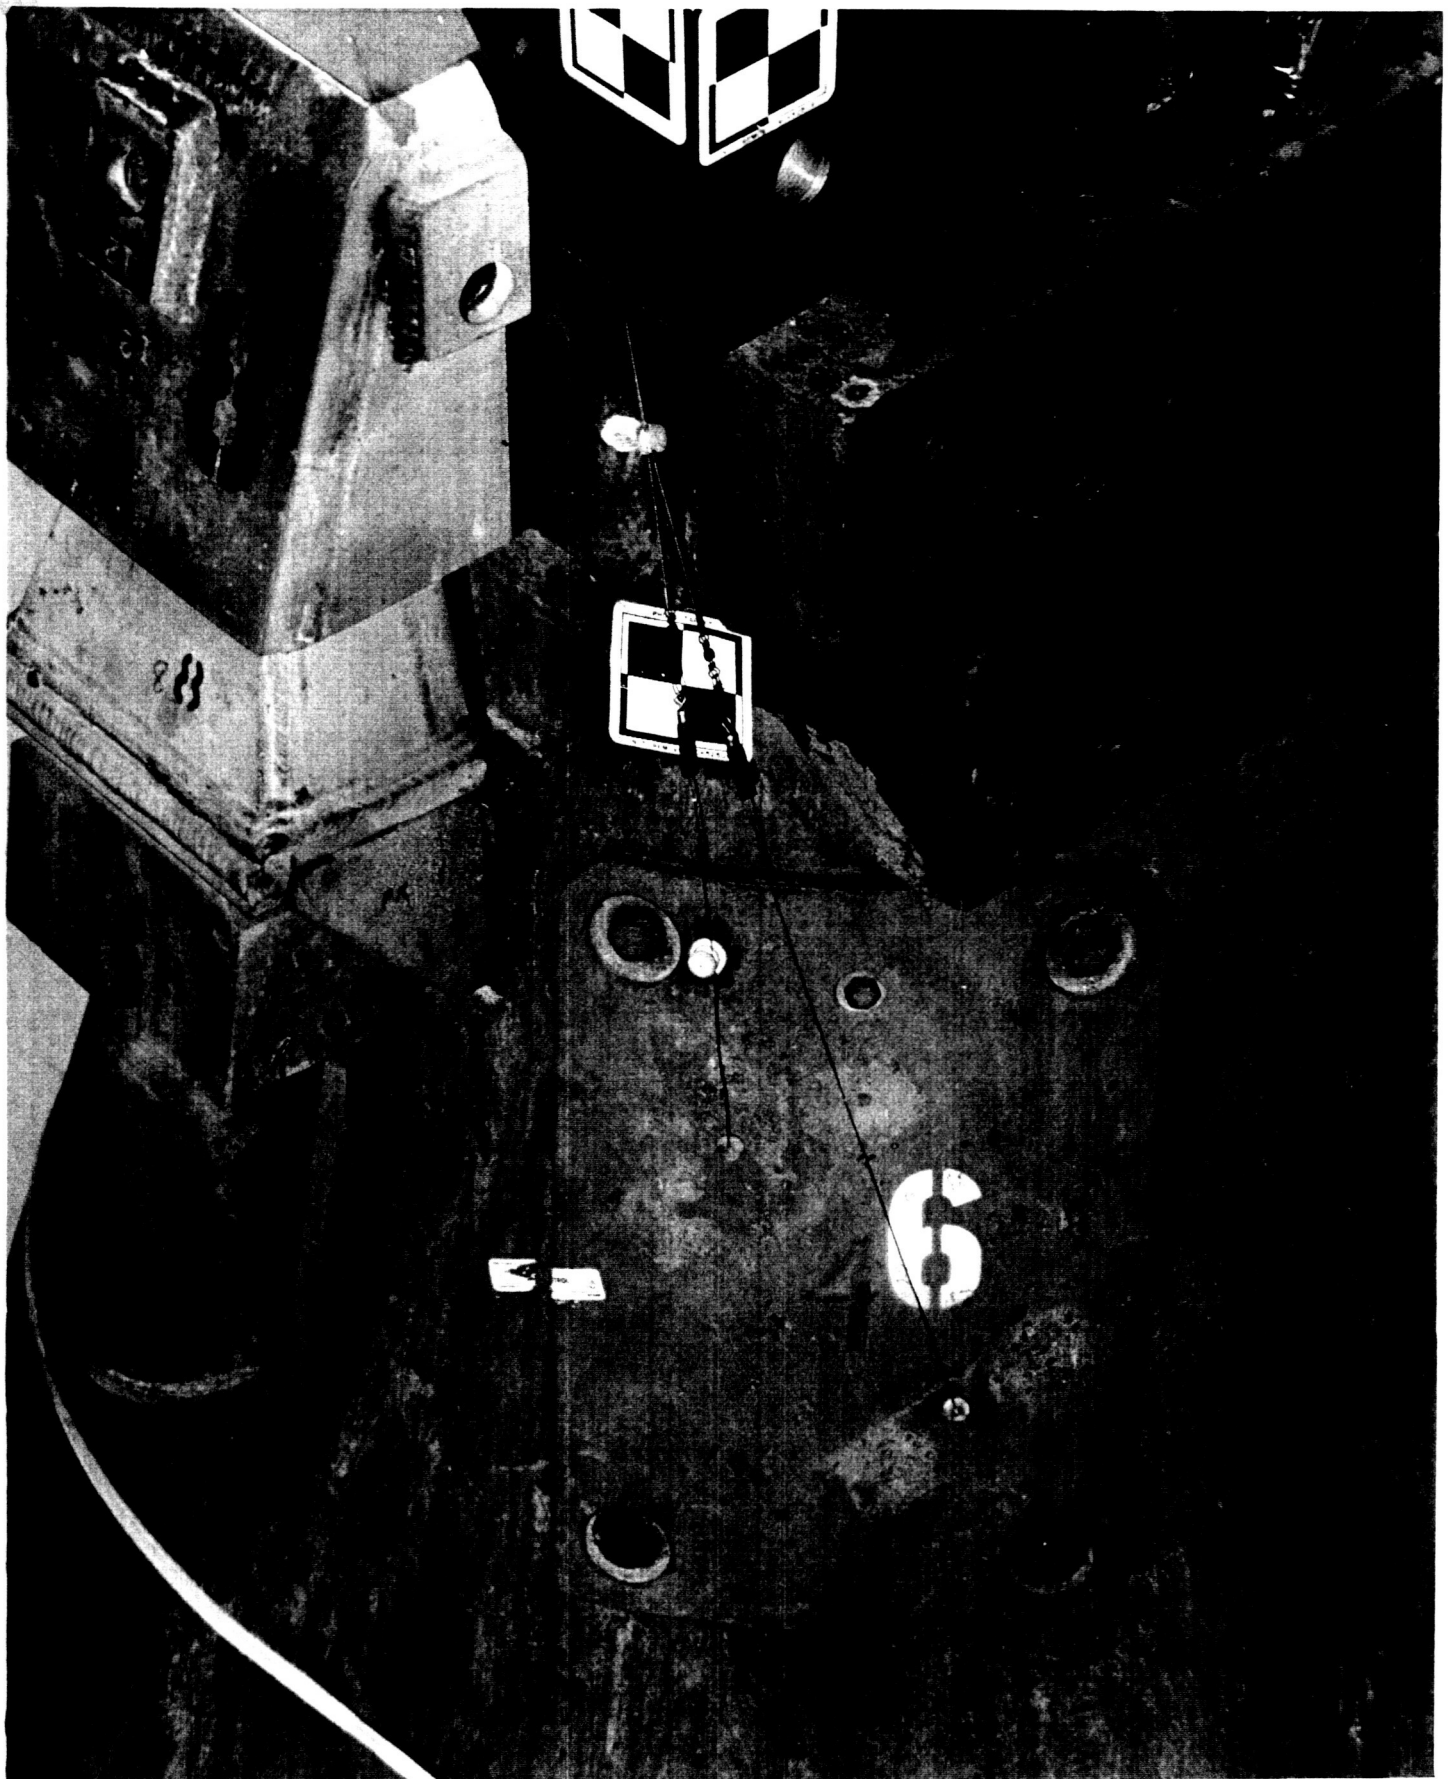
Components of the Holddown Post Bushing Bearing Rotation Measurement System had been designed to minimize debris during ignition and liftoff.

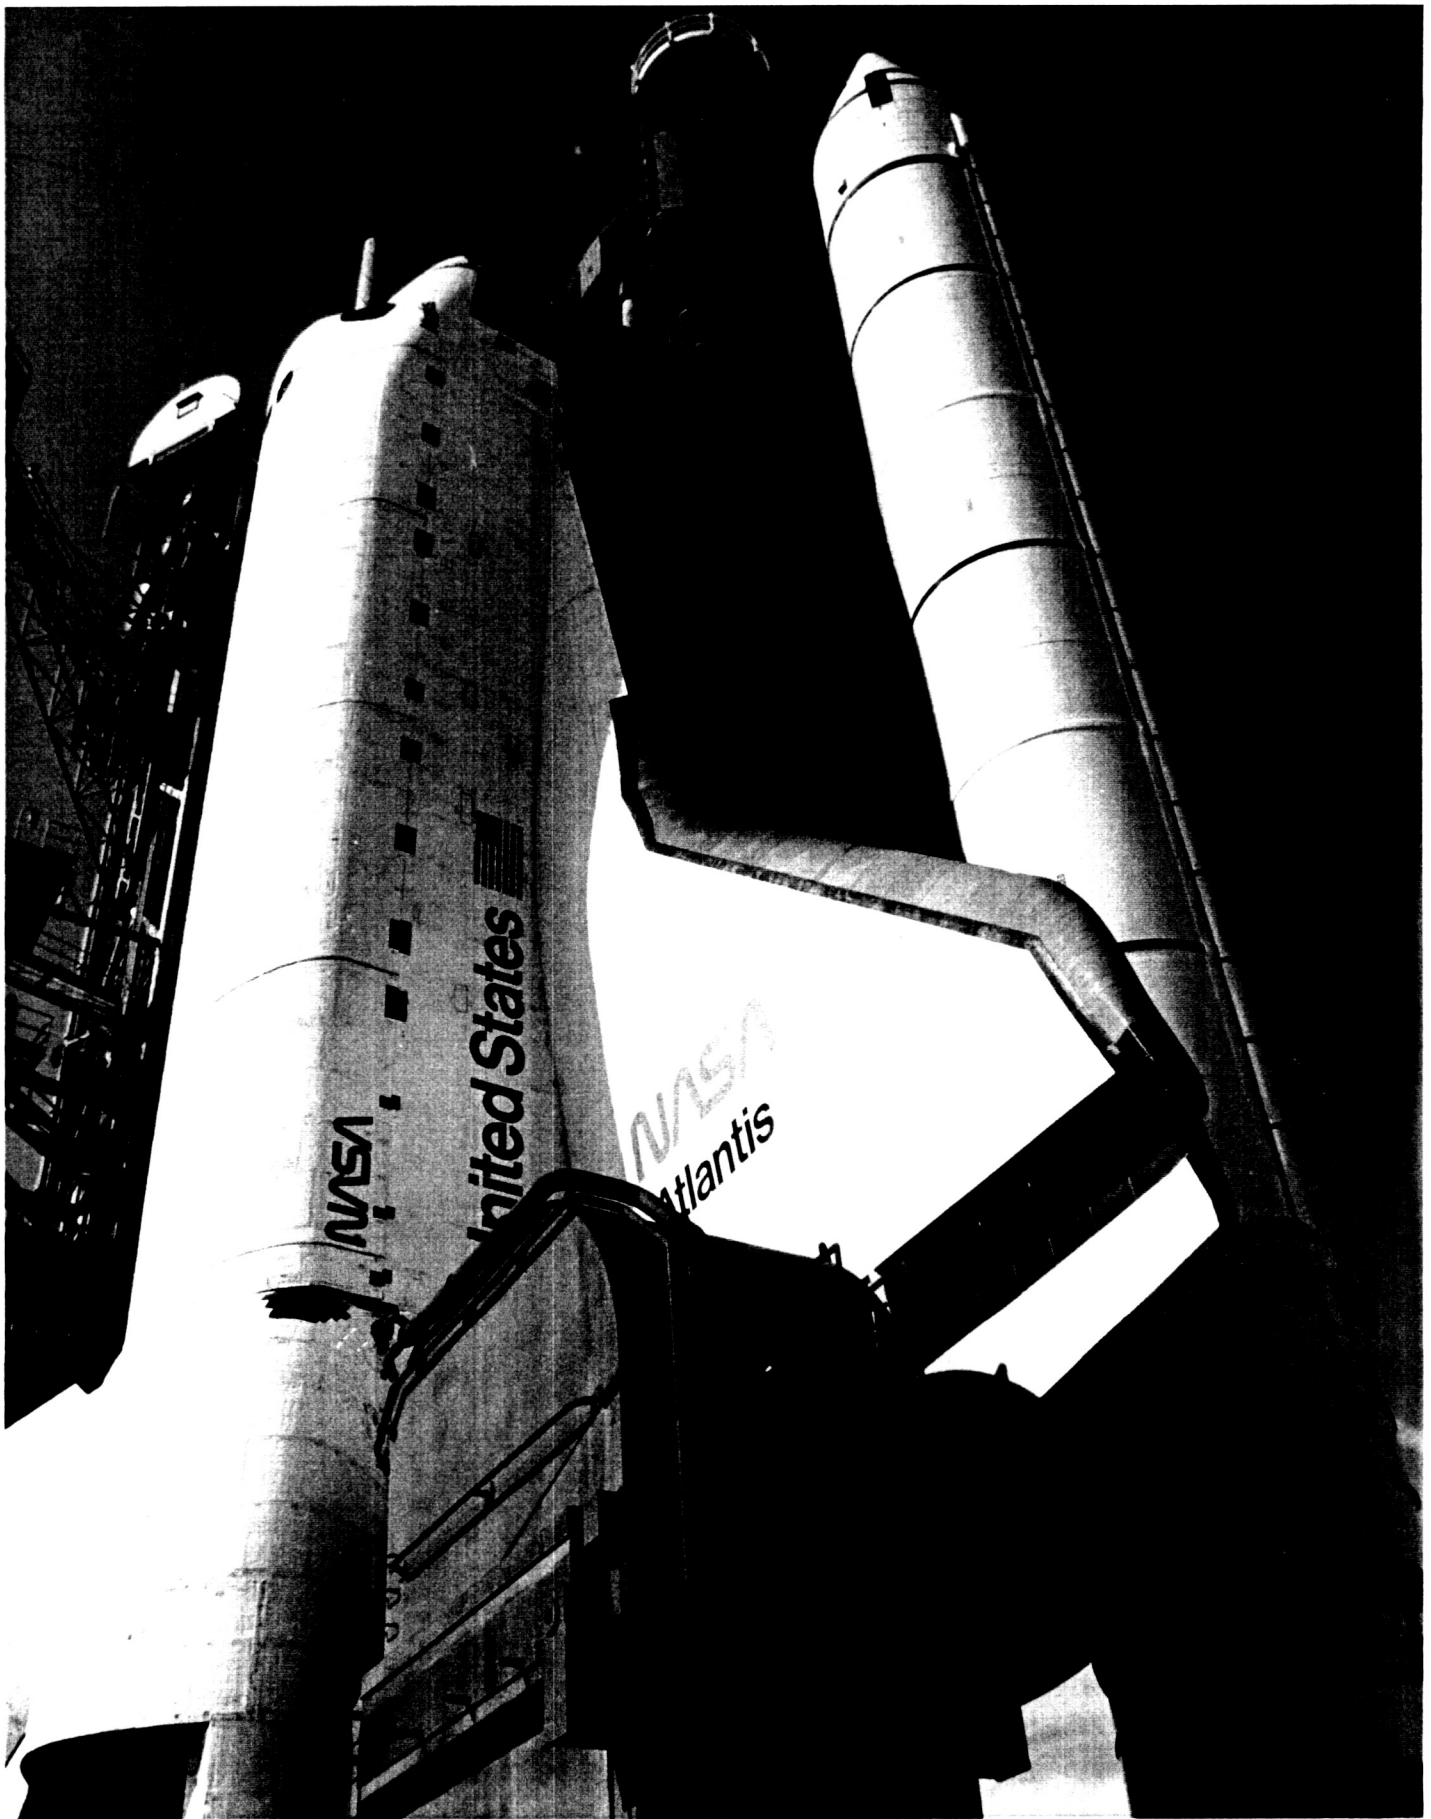
There were no TPS anomalies, ice/frost accumulations, or  
condensate on the External Tank acreage

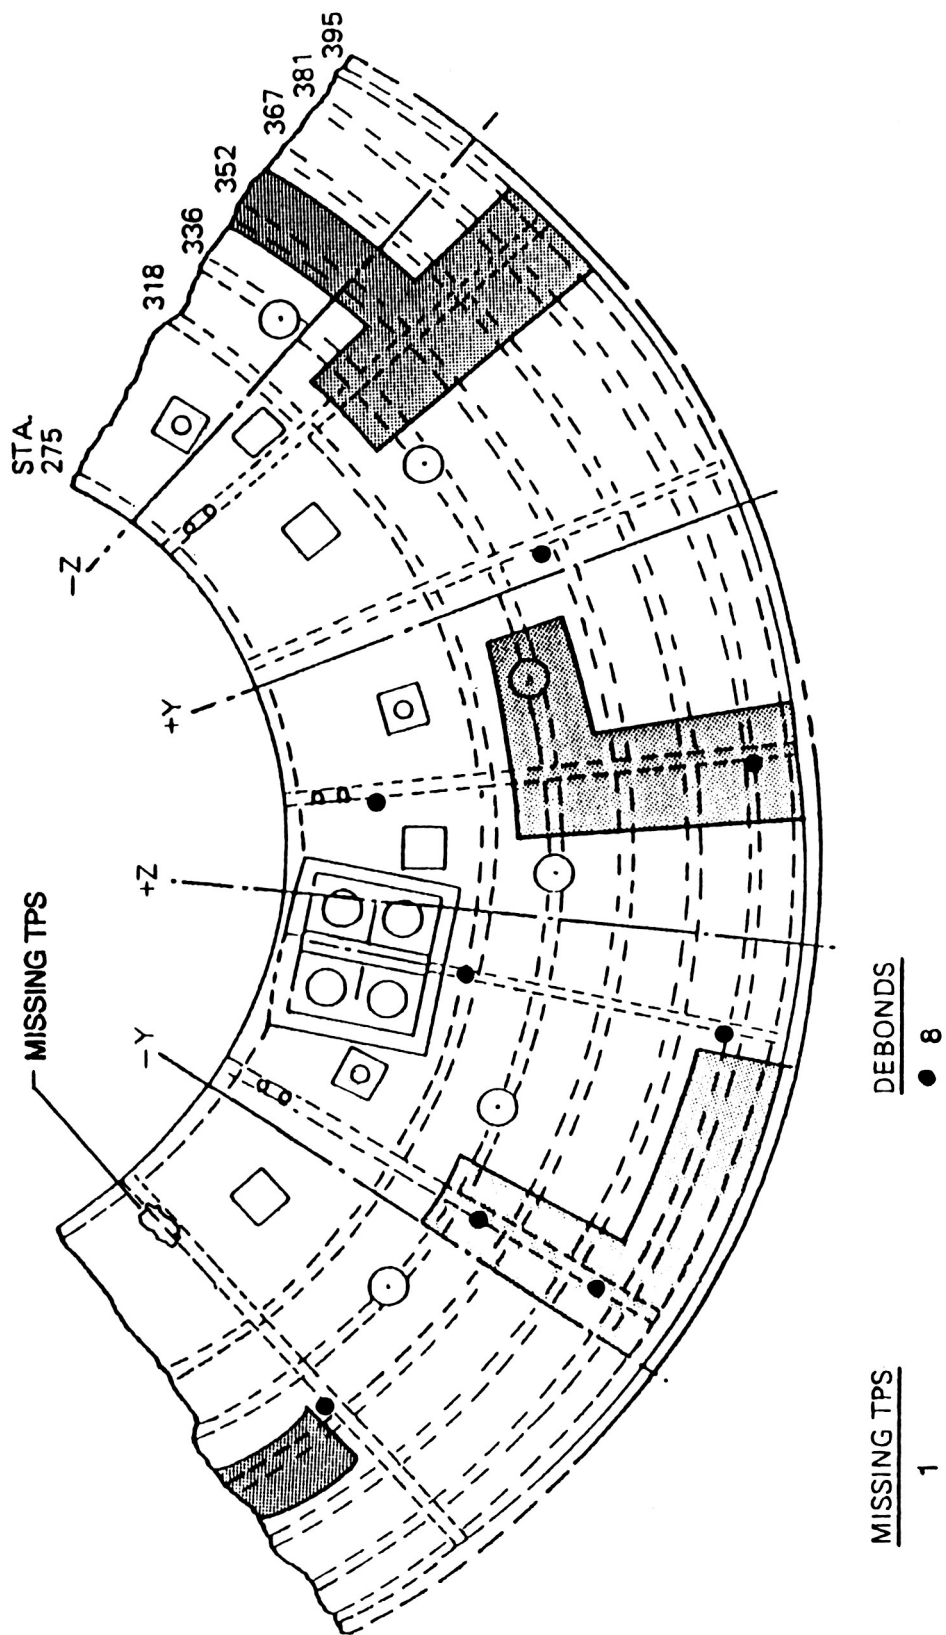
FIGURE 5. RIGHT SRB FRUSTUM

The RH frustum had one area of missing TPS and 8 MSA-2 debonds over fasteners. The missing TPS was located between the -Y and -Z axis near the 275 ring frame. The remaining material in the divot was not sooted and the TPS was most likely lost after re-entry. There was minor localized blistering of the Hypalon paint (Figure 5). All BSM covers were locked in the fully opened position.

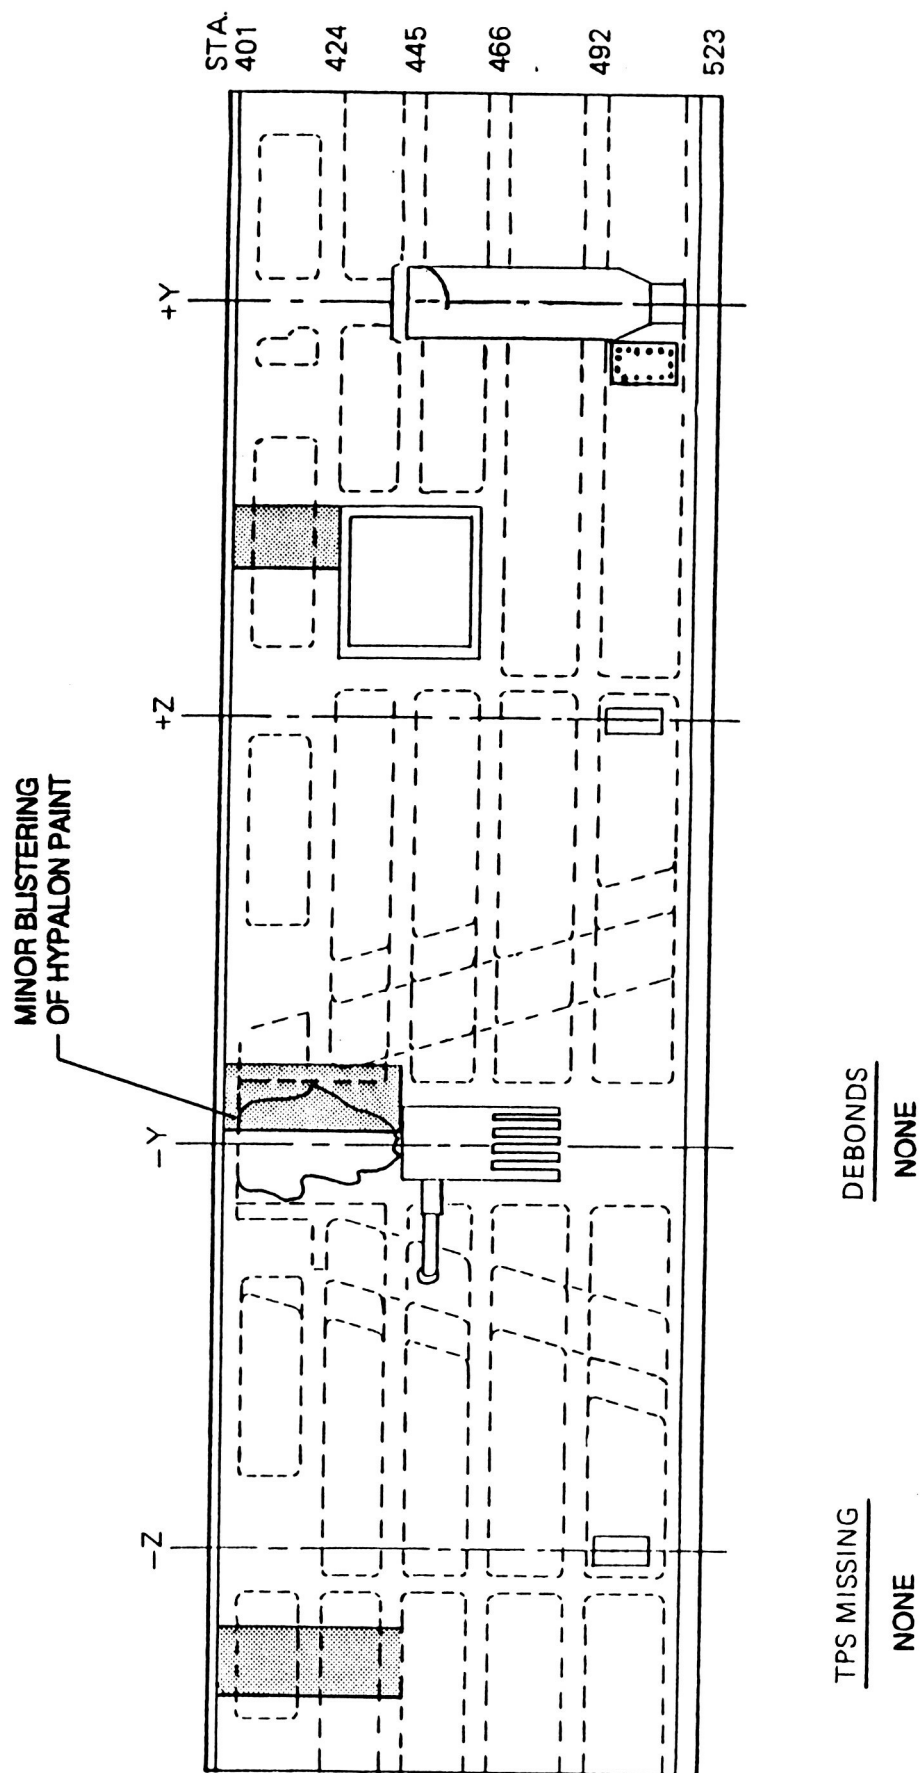
FIGURE 6. RIGHT SRB FWD SKIRT

The RH forward skirt exhibited no debonds or missing TPS. The phenolic plates on both RSS antennae were intact. The forward separation bolt and electrical cables appeared to have separated cleanly. No pins were missing from the frustum severance ring. Minor blistering of the Hypalon paint occurred forward of the ET/SRB attach point (Figure 6).

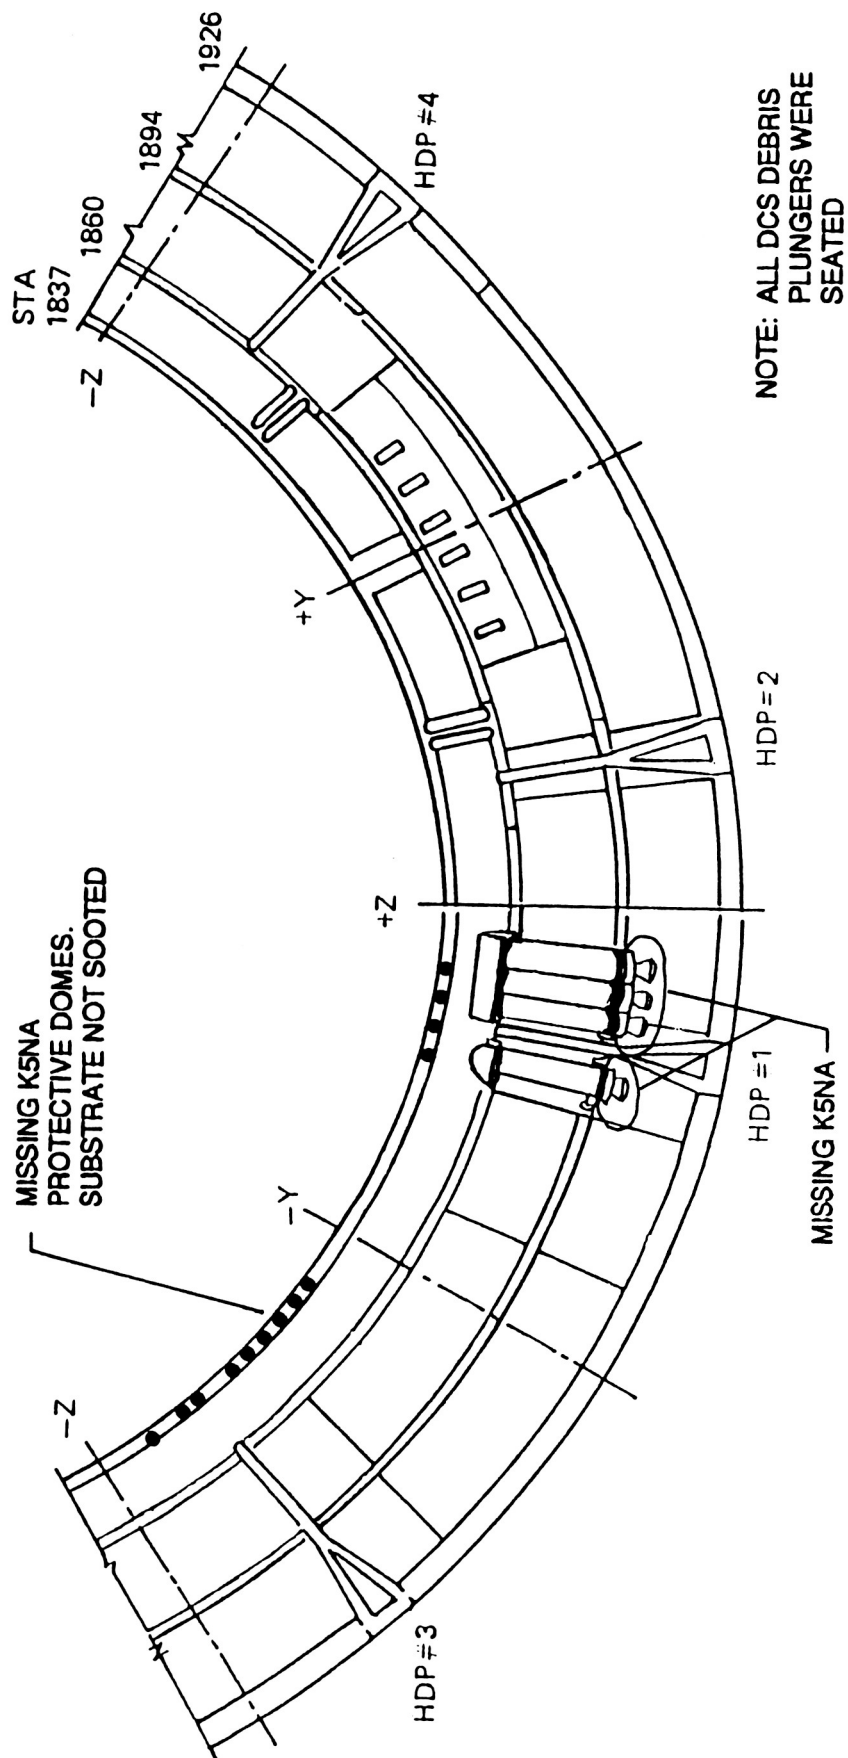
FIGURE 7. RIGHT SRB AFT SKIRT EXTERIOR TPS

The phenolic material on the kick ring was delaminated between the -Z and +Z axes. Thirteen K5NA protective domes between HDP #1 and #3 were lost from bolt heads on the aft side of the phenolic kick ring after water impact (clean substrate). The aft skirt acreage TPS was generally in good condition. K5NA was missing from all aft BSM nozzles (Figure 7). The TVC "rock" actuator strut/nozzle attach clevis was broken at water impact and was not a debris issue.

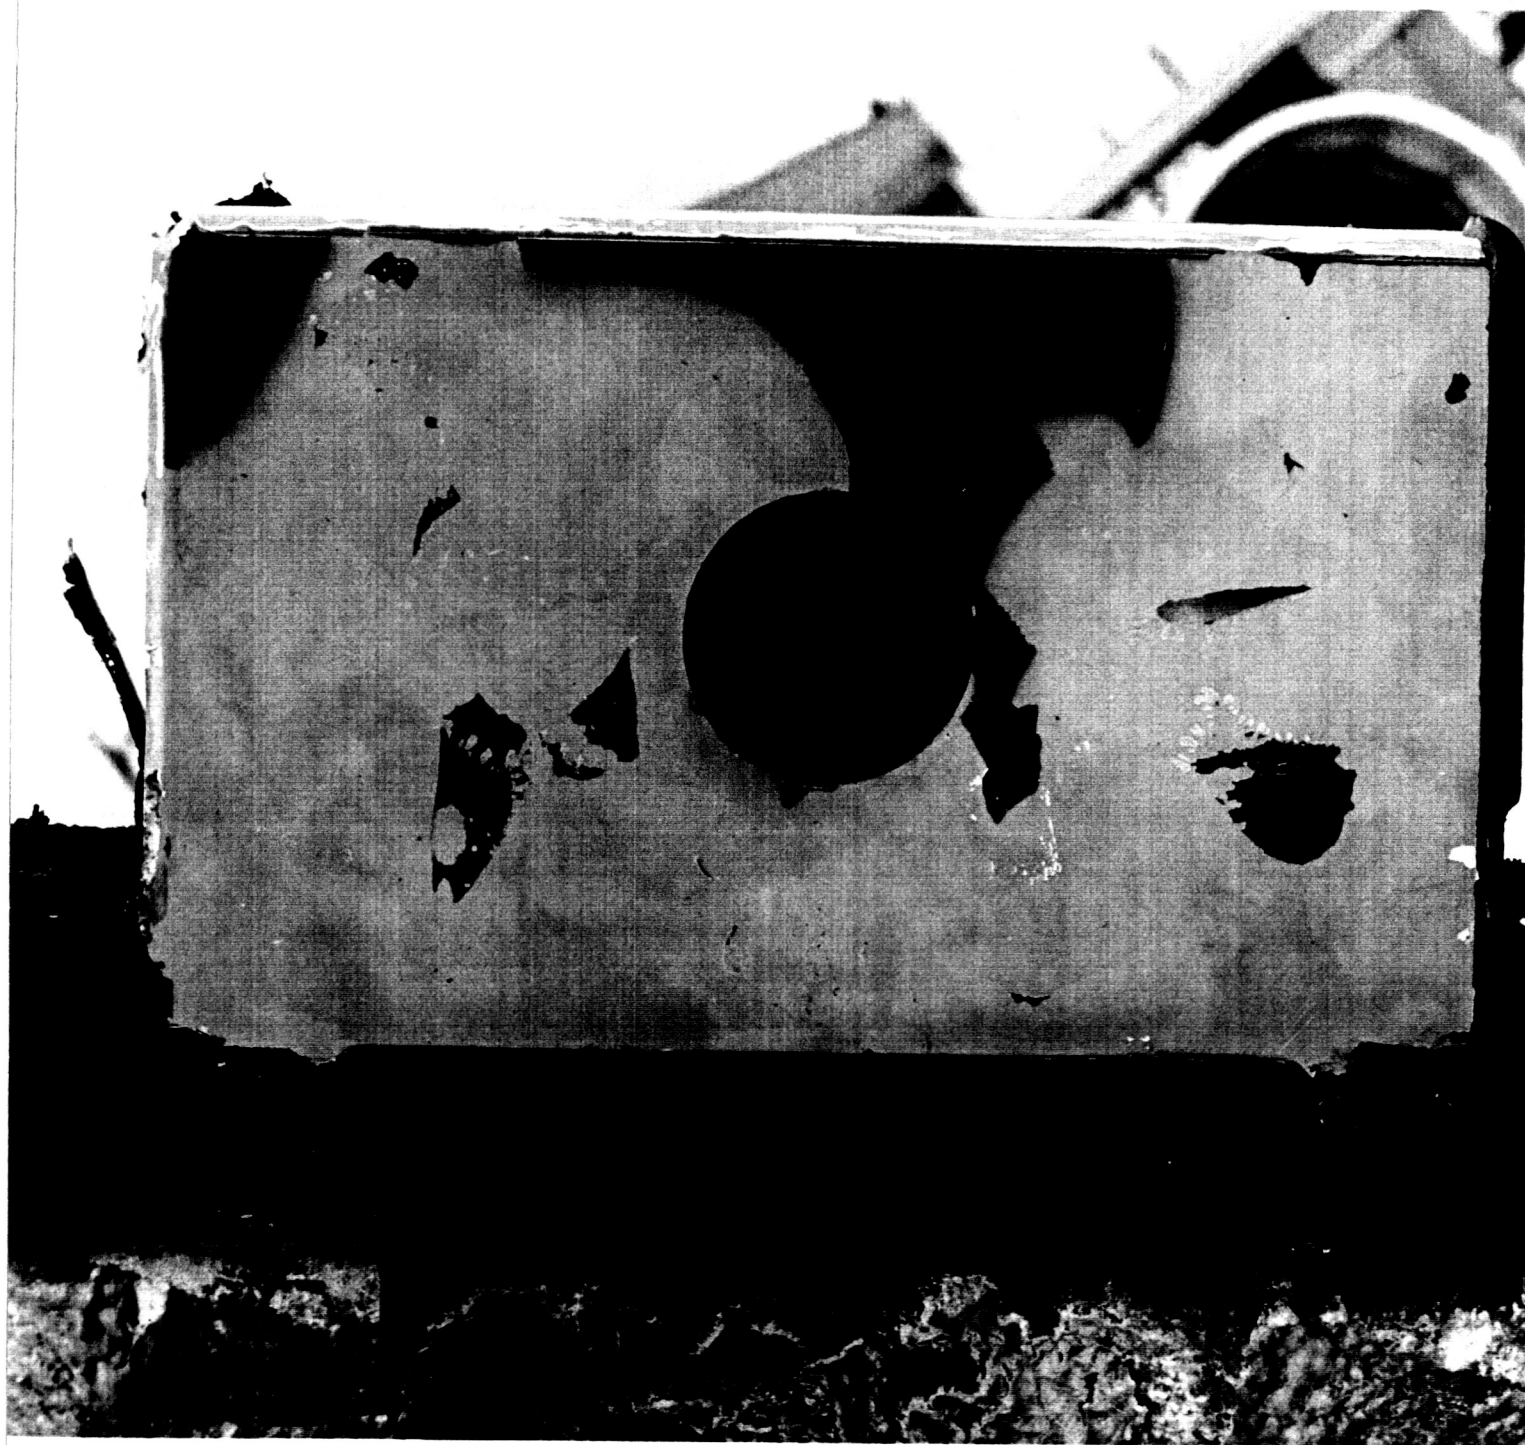
The phenolic material on the kick ring was delaminated between the -Z and +Z axes. Thirteen K5NA protective domes were lost from bolt heads on the aft side of the phenolic kick ring after re-entry.

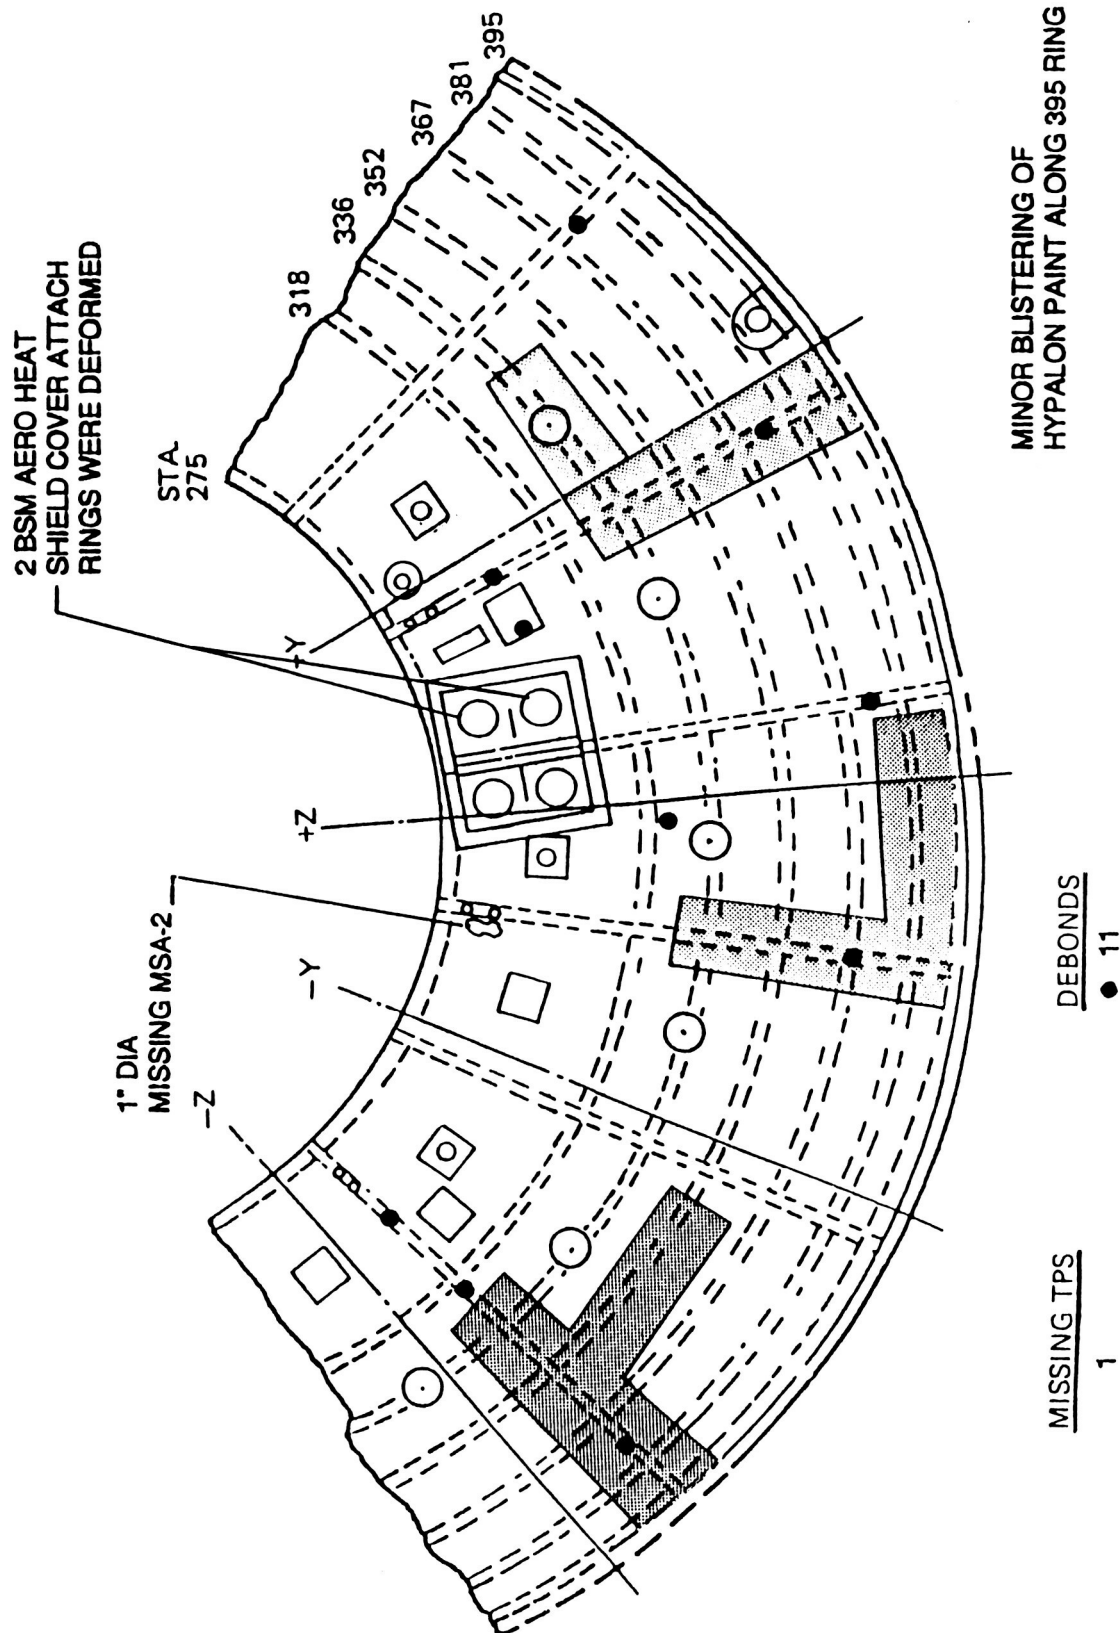
FIGURE 8. LEFT SRB FRUSTUM

The LH frustum had one area of missing TPS and 11 MSA-2 debonds over fasteners. The missing TPS was located between the -Y and +Z axis near the 275 ring frame. The remaining material in the 1 inch diameter divot was not sooted and the TPS was most likely lost after re-entry. There was minor localized blistering of the Hypalon paint (Figure 8). The BSM covers were locked in the fully opened position though the upper and lower right cover attach rings were deformed and the covers bent back to the 135 degree position.

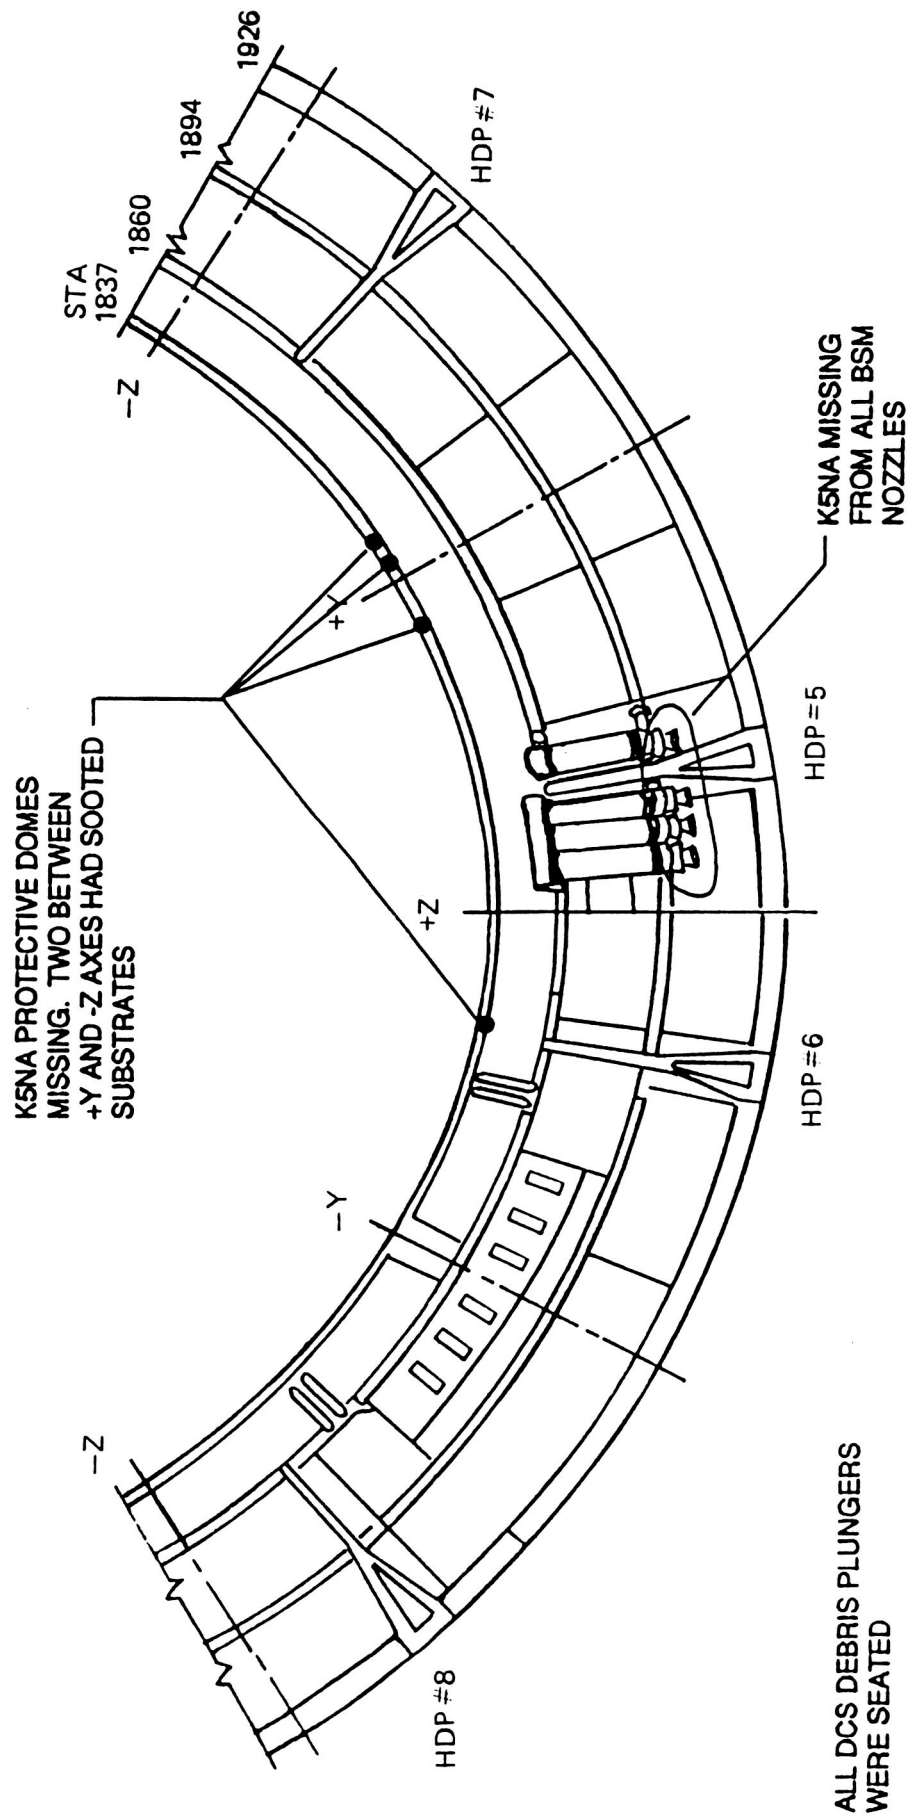
FIGURE 10. LEFT SRB AFT SKIRT EXTERIOR TPS

Four K5NA protective domes were missing from bolt heads on the phenolic kick ring. Two of these domes were lost prior to water impact (charred substrate). The aft skirt acreage TPS was in generally good condition (Figure 10). K5NA was missing from all aft BSM nozzles.

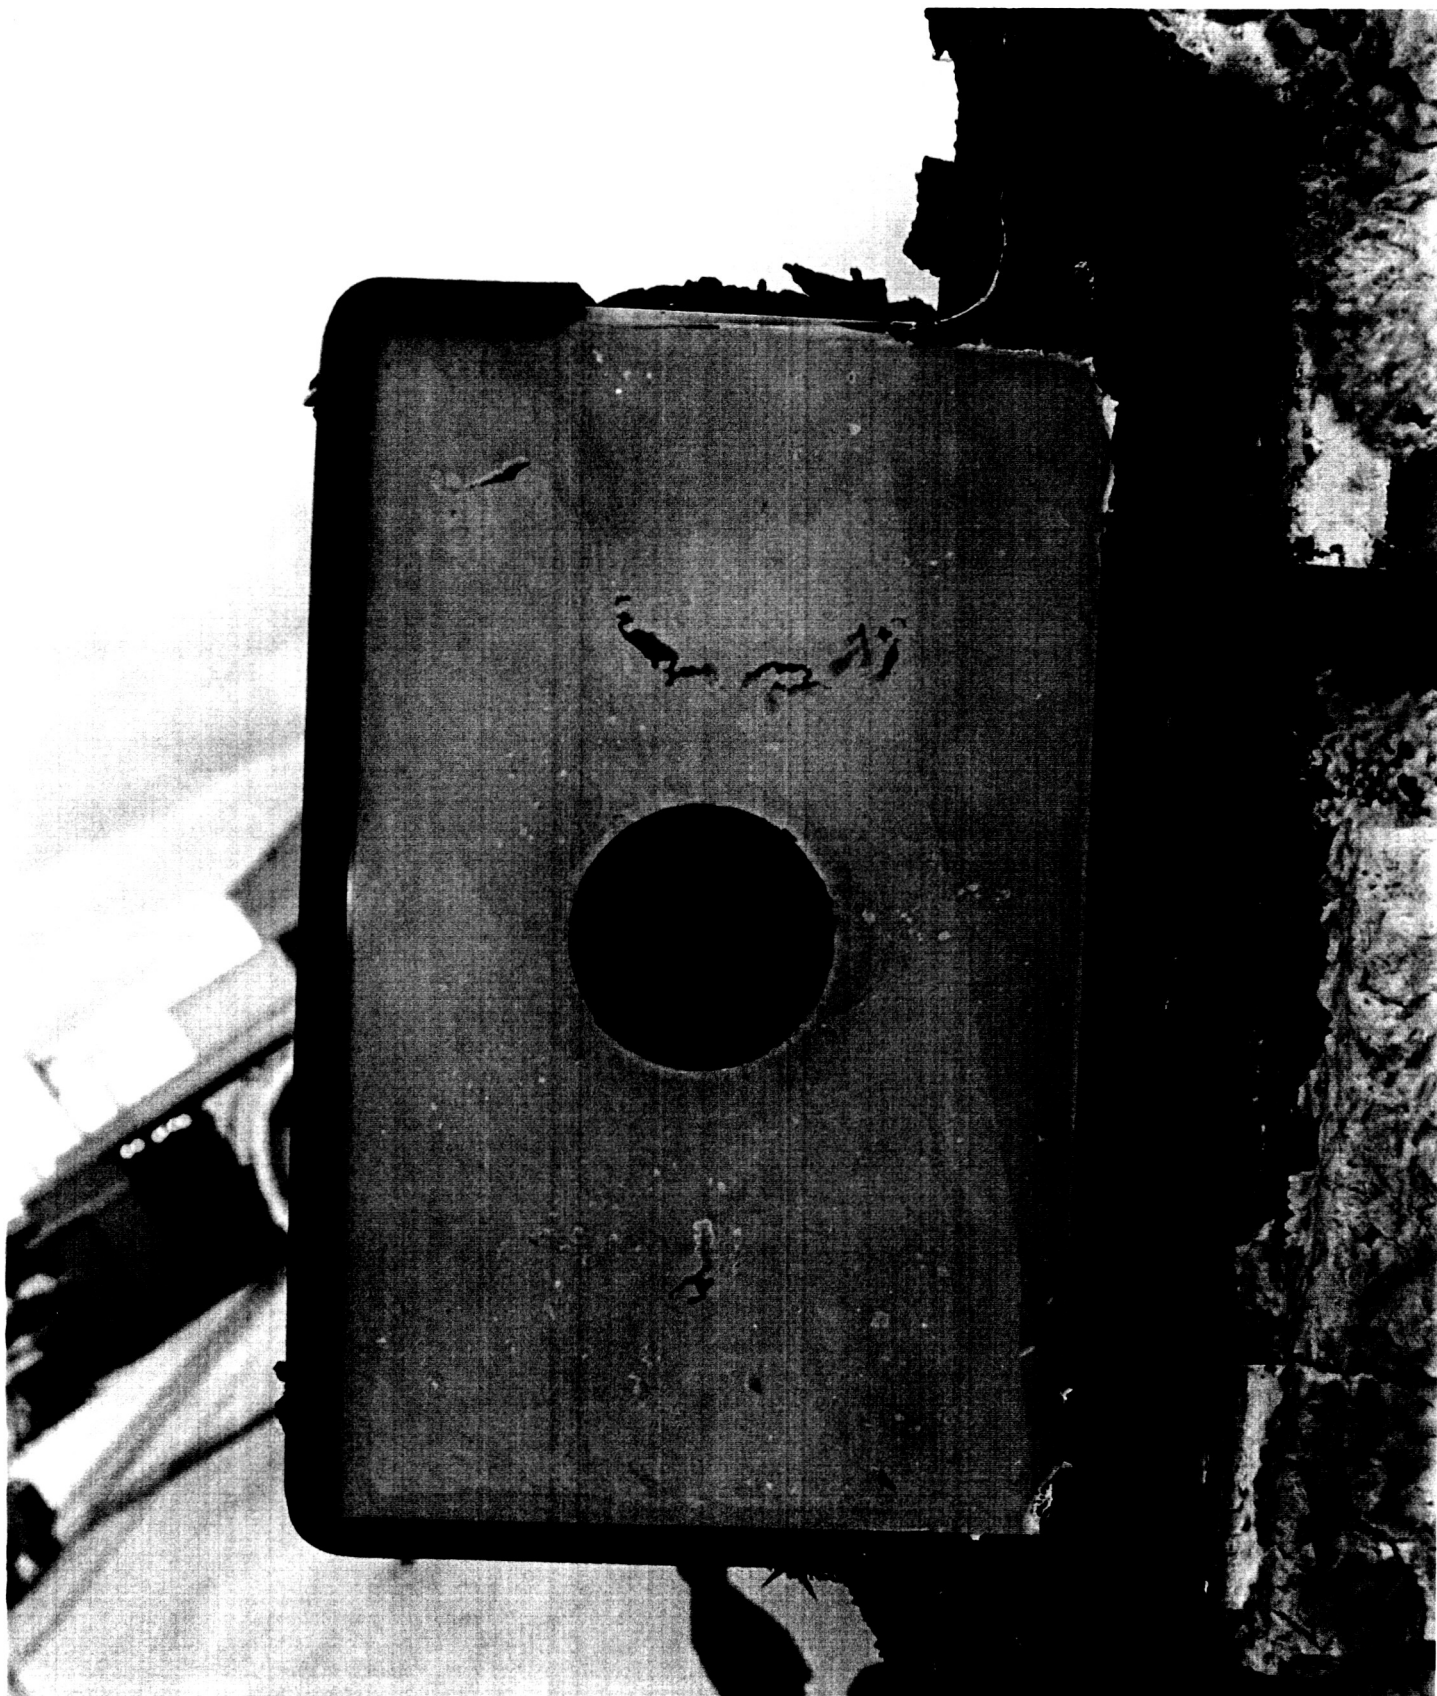
The phenolic material on the kick ring was intact and had not delaminated. K5NA protective domes were missing from bolt heads on the phenolic kick ring prior to water impact. The substrate under the missing domes was sooted.

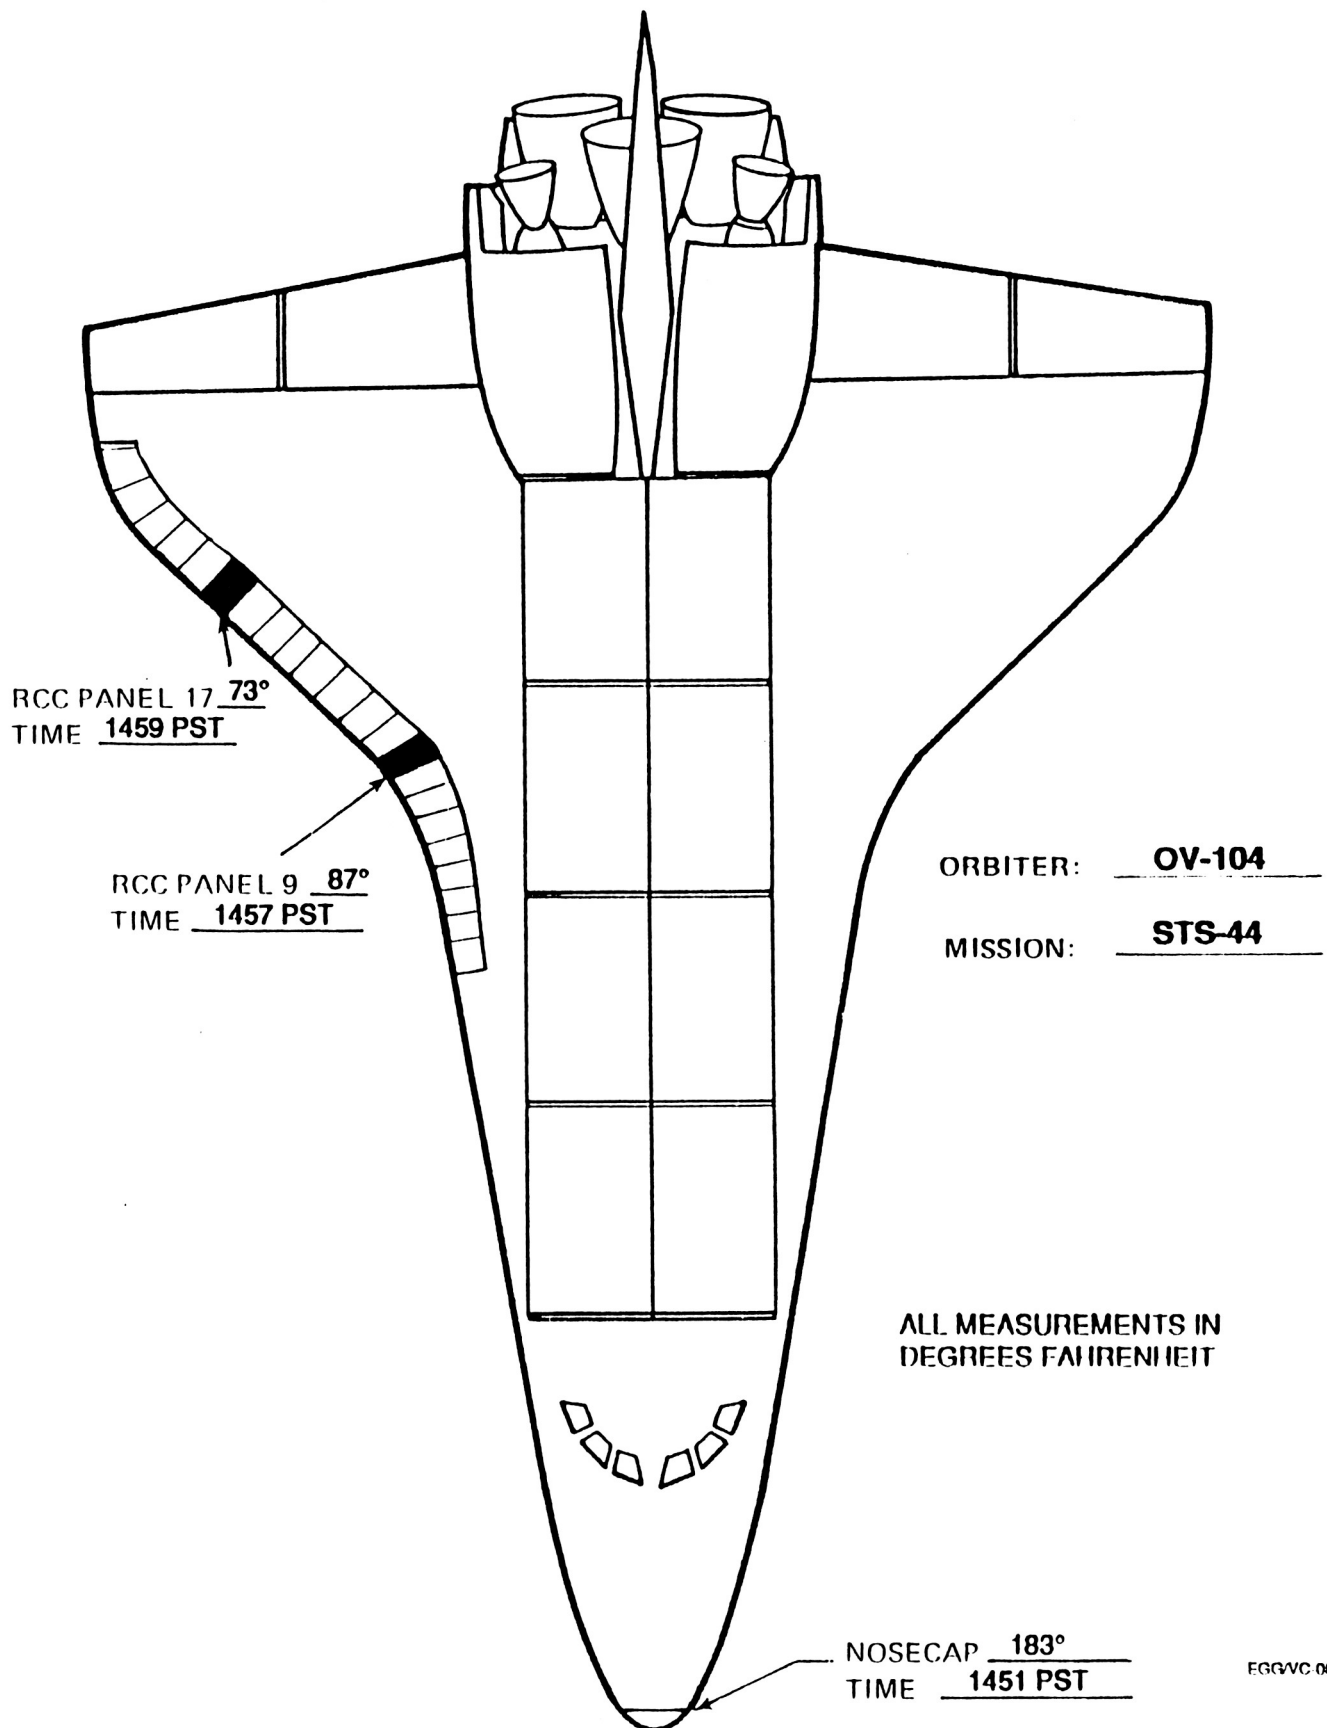
FIGURE 16. STS-44 RCC TEMPERATURE MEASUREMENTS AS  
RECORDED BY THE SHUTTLE THERMAL IMAGER  
TEMPERATURE MEASUREMENTS

A portable infrared thermometer was used to measure the surface temperatures of three areas on the Orbiter TPS after landing (OMRSD V09AJ0.095). Seventeen minutes after wheel stop the Orbiter nose cap RCC was 183 degrees F. Twenty-four minutes after landing, the RH wing leading edge RCC panel #9 was 87 degrees F and the RH wing leading edge RCC panel #17 was 73 degrees F (Figure 16).
